# TV8-301W(E&T)

## SERVICING GUIDE

☆The SONY Transistor TV 8-301 is designed on the following requirements.

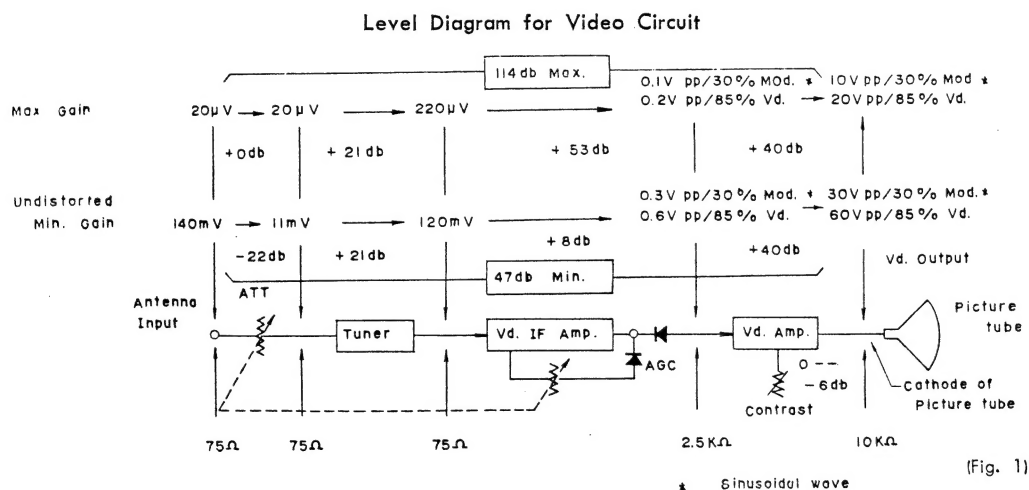
#### 1. Video Signal Circuit (See Fig. 1)

Required video output for the picture tube is 10 Volts p-p for the 30% AM antenna input signal against 20 Volts p-p which is required in the conventional set.

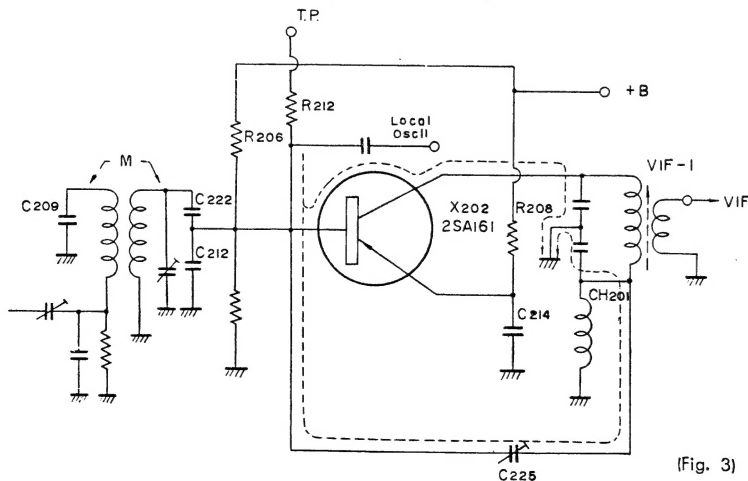
(Fig. 3)

Neutralizing in Mixer Stage

To prevent this trouble, conventional neutralizing network is used as shown in Fig. 3.

Although the undesirable feed back can be prevented by short circuiting the base and the emitter of the transistor with respect to the IF frequency inserting a trap into the input circuit, it is not desirable to do this because the IF characteristics around the resonant frequency of the trap will be deteriorated.

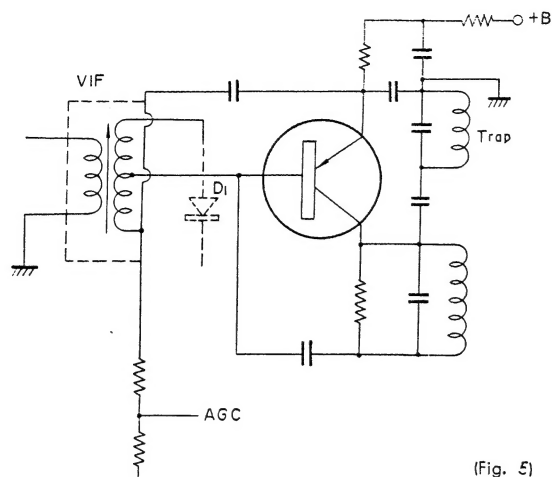
(Fig. 5)

Fundamental circuit for each stage is shown in Fig. 5.

A  $5\mu\text{F}$  capacitor connected between the emitter and the base in each stage prevents intermodulation which will cause phase distortion in the video signal.

## Fundamental Circuit for VF Amplifier

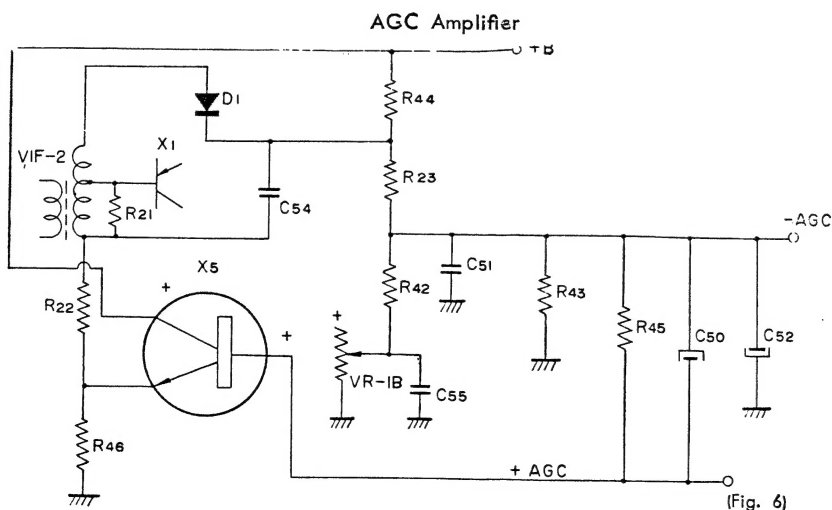
(Fig. 6)

Gain control potentiometer VR-1A serves to attenuate the input signal level for the tuner by 20 dB max.

Overall gain control range reaches 60 dB as VR-1A incorporates with VR-1B, the bias control for D1, as mentioned above.

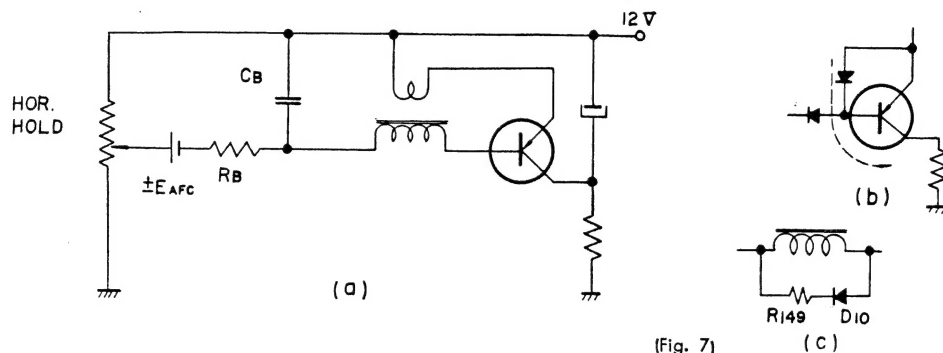
Fundamental Circuit of Horizontal Blocking Oscillator

Fig. 7a shows the fundamental oscillator circuit in which the oscillation frequency is controlled by varying the base bias voltage for the transistor. As obvious in the figure, the AFC voltage is fed in series with the base circuit.

Although a L-C tank circuit tuned to 15.75 Kc is provided in the base circuit, the oscillation frequency tends to drift due to the variation of the characteristics of the transistor as the temperature changes. This problem is solved by using the transistor 2SB511 specially chosen in the standpoint of stable operation. There are some discrepancies in the arrangements of the oscillator between the types of the TV set.

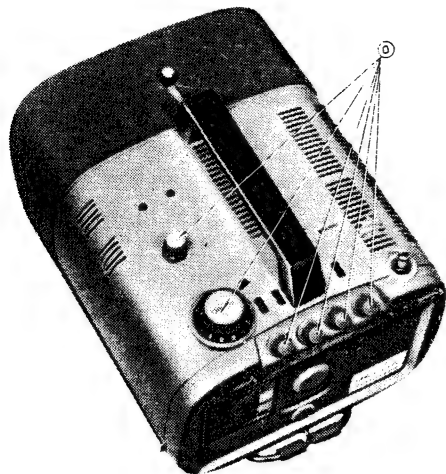
(Fig. A)

- 1) Remove six knobs (a) by pulling up straight.

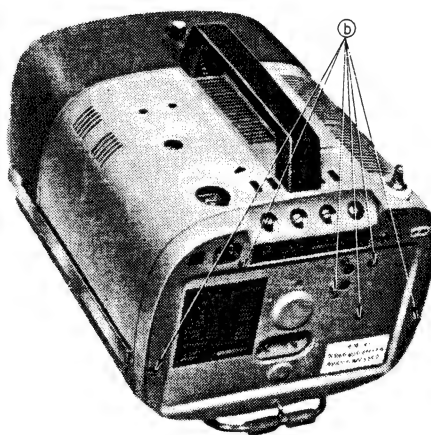
(Fig. B)

- 2) Remove six screws (b).

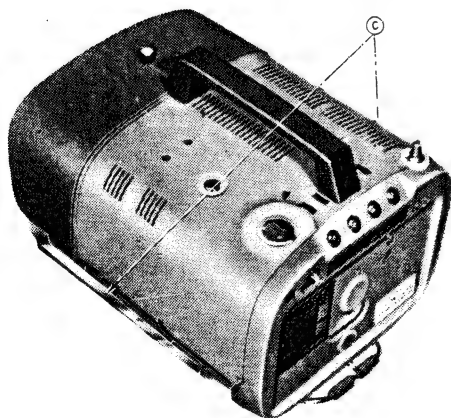
(Fig. C)

- 3) Remove two ornamental strips (c), one each side

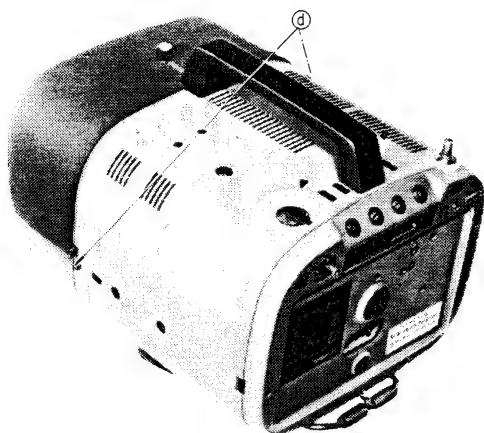
(Fig. D)

- 4) Remove two screws (d) on both sides (Fig. D), one each side, and one screw (e) on the bottom (Fig. E).

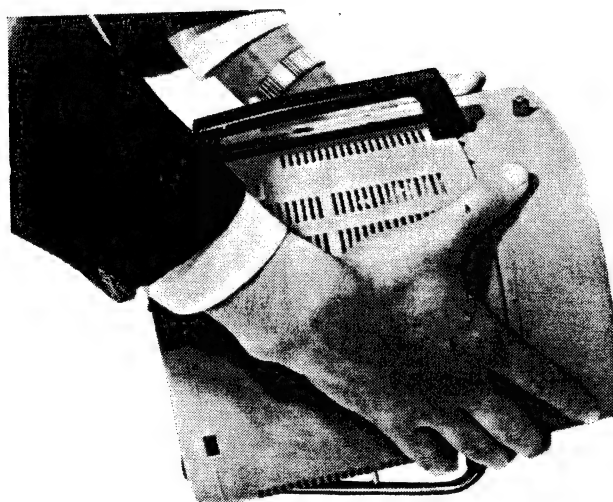
(Fig. F)

- 5) Hold both sides of the Back Cover with the hands firmly and push the Front Cover forward. The Back Cover will then be detached.

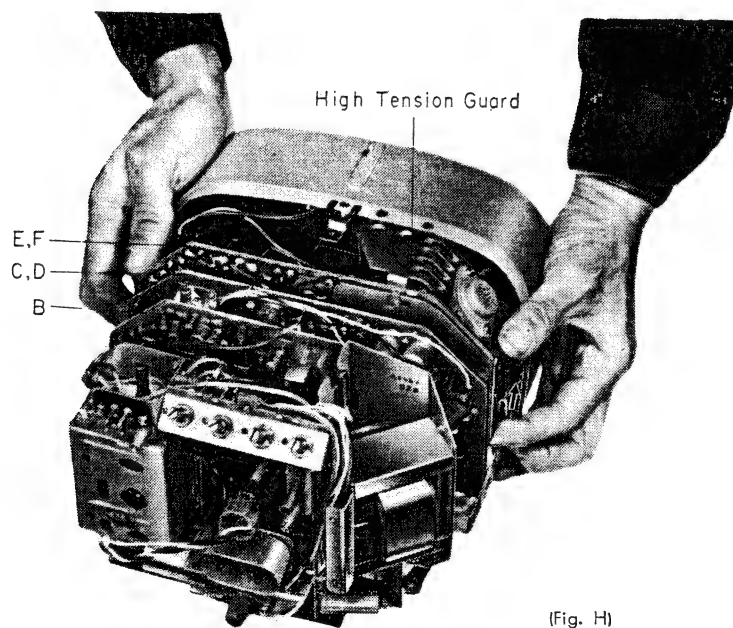
- 2) To take out the circuit board E, F, push upward of the lower end of the high tension guard as shown in Fig. H.

Remove the anode connector for the picture tube behind the high tension guard.

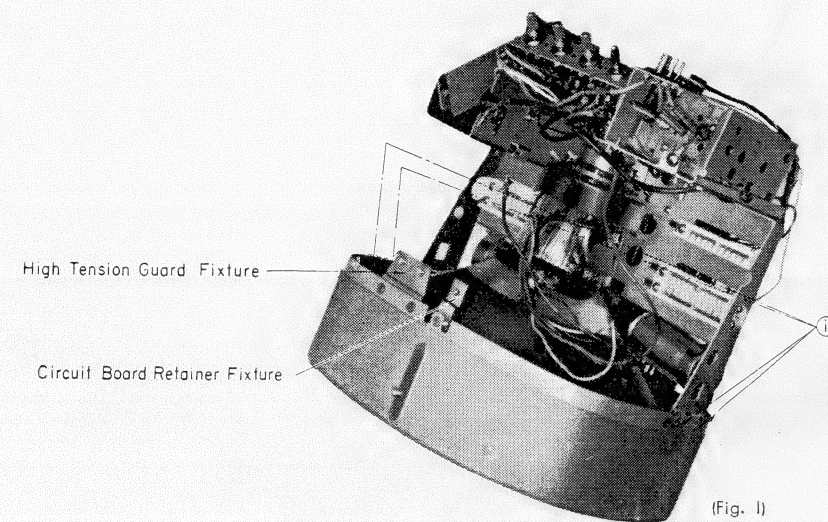
- 1) Remove the circuit board retainer fixture and high tension guard fixture.
- 2) Remove the picture tube socket.
- 3) Remove six screws (i), four on both sides of the front frame and two on the bottom (Fig. E), and disengage the chassis and the front frame (Fig. I).

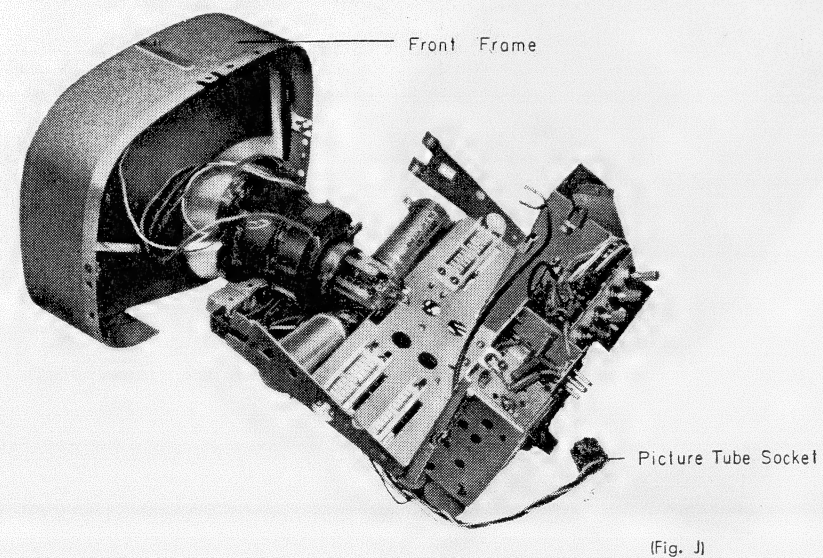
Then the front frame and the chassis will be separated as shown in Fig. J.

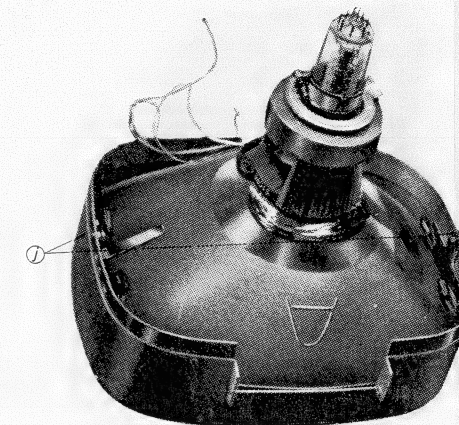
(Fig. K)

- 4) Remove two screws (J) to dismount two picture tube retainers.

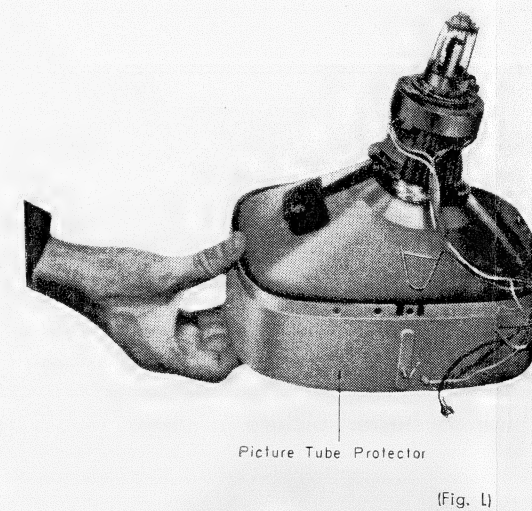
(Fig. L)

- 5) Push the picture tube protector as shown in Fig. L, and the tube will be removed from the front frame (Fig. M)

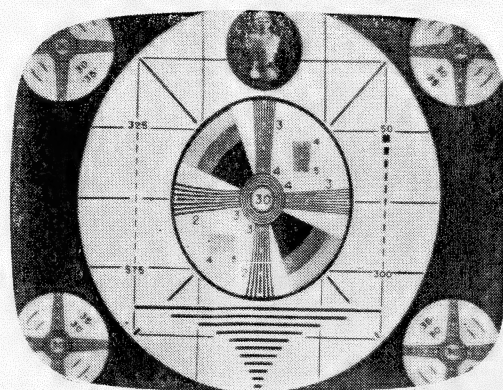
# Properly Adjusted Picture

Vertical Resolution      Approx. 400 lines  
Horizontal Resolution      Approx. 400 lines  
Adjust (H), and (I) to obtain circle on the test pattern.

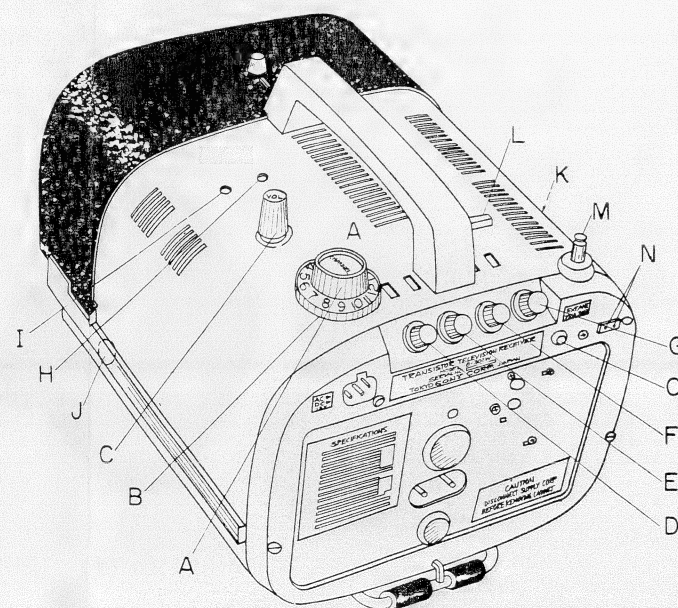
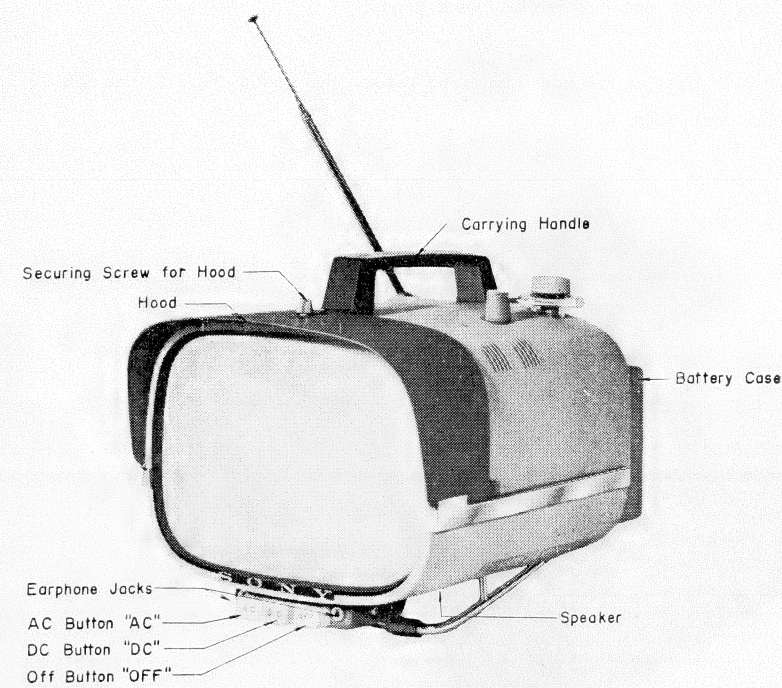
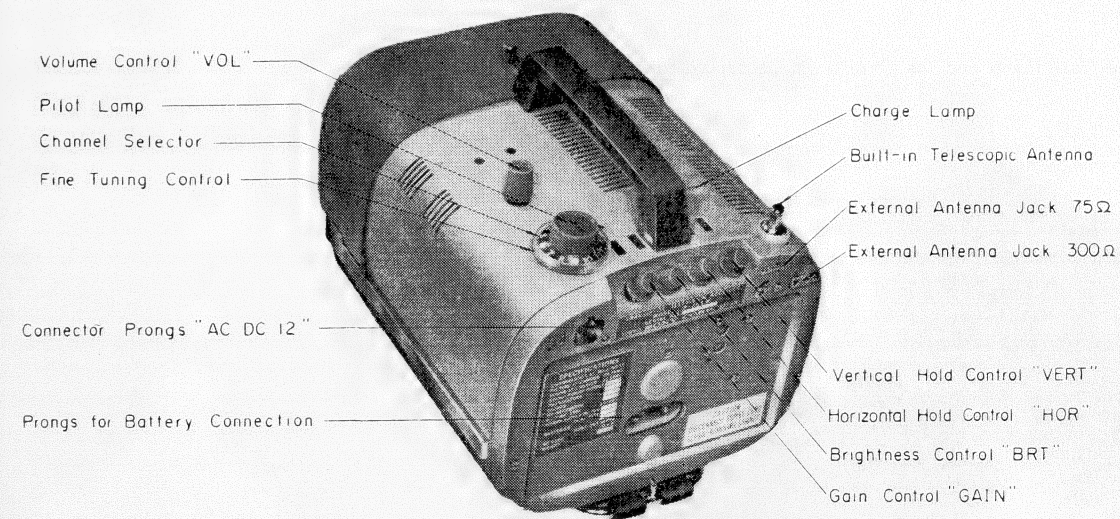
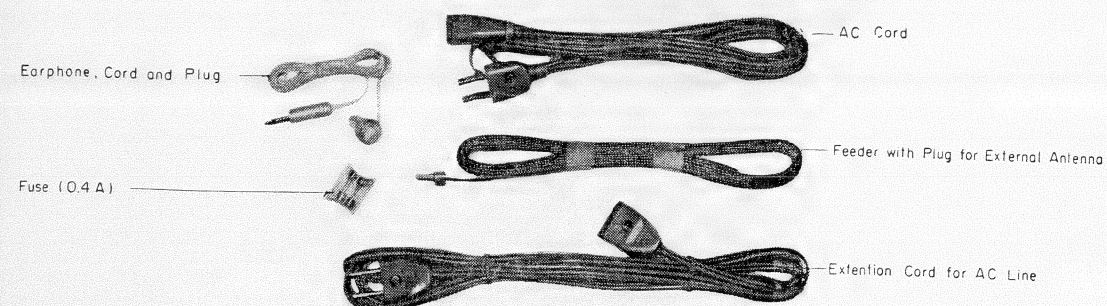
## Reference Drawing for "How to obtain a better picture"

- A "CHANNEL" Channel Selector
- B Fine Tuning Control
- C "VOL" Volume Control
- D "GAIN" Gain Control
- E "BRT" Brightness Control
- F "HOR" Horizontal Hold Control
- G "VER" Vertical Hold Control
- H Vertical Linearity Control
- I Height Control
- J Horizontal Sweep Frequency Control
- K Horizontal Drive Control
- L Charge Lamp
- M Built-in Telescopic Antenna
- N External Antenna Jack 300Ω
- O External Antenna Jack 75Ω
